■  
Rimshin V.I.  
Ketsko E.S.  
Kuzina I.S.

#### Rimshin Vladimir Ivanovich,

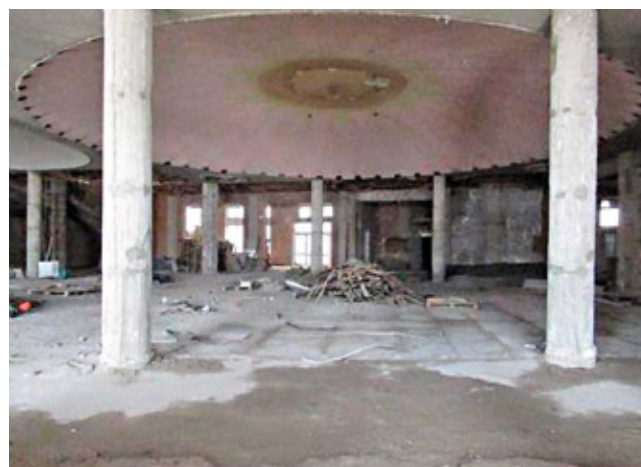
Fig. 5. The general view of the first-floor premises

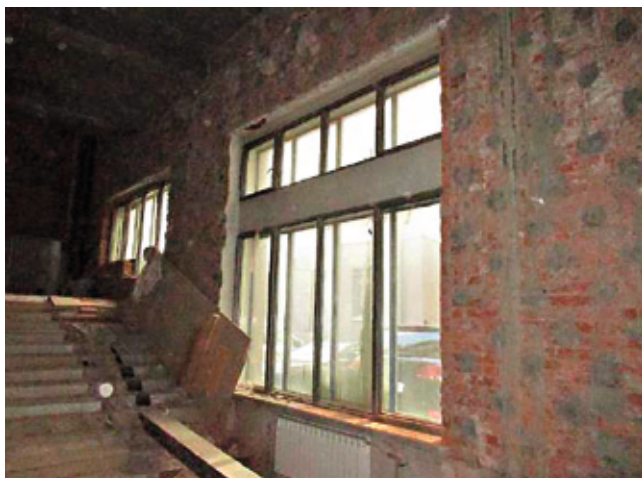
Fig. 7. The masonry mortar weathering, local damage to the brickwork of the walls on the first floor

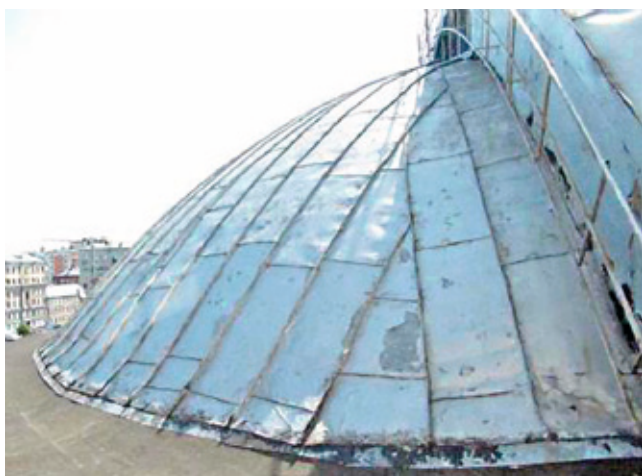
Fig. 8. Deformation, mechanical damages, corrosion, reduced tightness of metal sheet seam fasteners on the building's dome roofing
