Technical and regulatory aspects of establishing signs of emergency of apartment buildings within the framework of forensic construction and technical expertise

**Keywords:** forensic construction and technical expertise, emergency housing stock, technical and regulatory signs of emergency, dilapidated condition of the building, emergency technical condition of the building

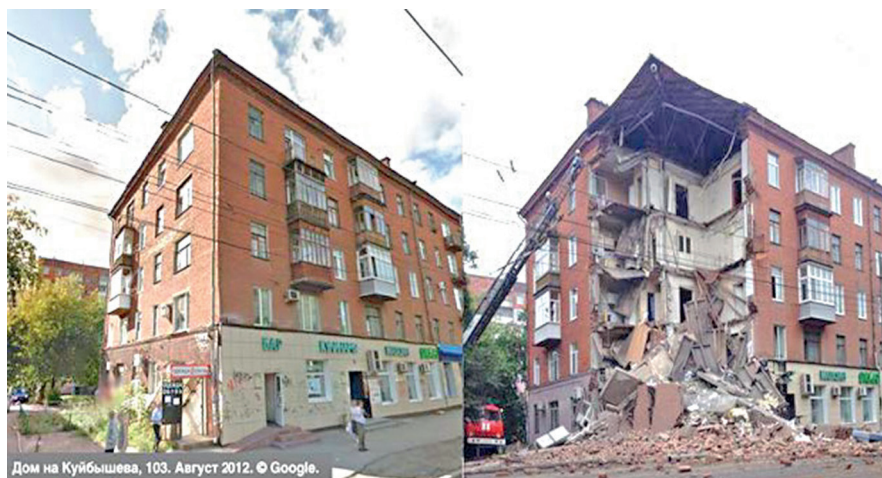
Fig. 1. General view of an apartment building in Kuibyshev Street in Perm before and after the collapse

On 11.07.2015, the corner part of a 5-storey residential building on Kuibyshev Street in Perm collapsed (Fig. 1). The house was built in 1957. It was established that before the collapse, the reconstruction and redevelopment of the basement premises was carried out. During the reconstruction, instead of the loading hatch of the store, an entrance group to the basement was made, for which the sill section of the window opening was dismantled and a recess for the installation of an external staircase was filled in, as well as a new opening in the inner load-bearing wall, which was not provided for by the project.

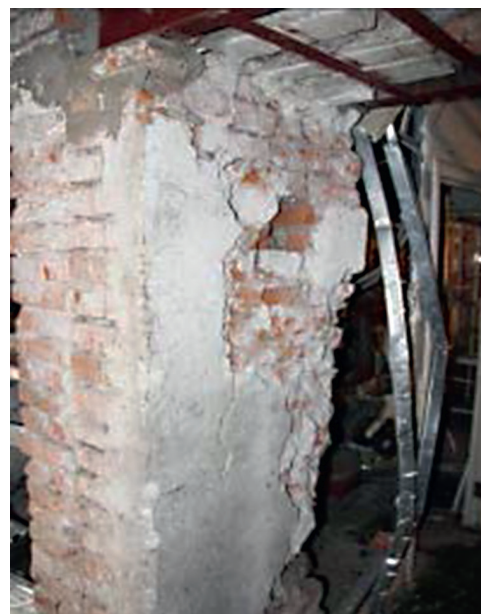
Fig. 2. View of the pillar of the non-designed opening in the basement, which was the source for activating the process of destruction of the building (the state of the pillar, recorded before the collapse of the corner of the building)

After the reconstruction, force damage was observed in the newly formed basement pillar in the form of cracks separating the integrity of the masonry section, chipping of bricks in peripheral sections of the pillar, and a network of cracks under the lintel support crossing more than four rows of masonry. These damages occurred as a result of the redistribution of loads from the overlying structures after making changes to the vertical supporting structures of the basement part of the building (Fig. 2). Vertical cracks

formed on the exterior walls, which subsequently separated the collapsed fragment, as a result of cyclic freezing of the soil base in a deepened hole under the exterior staircase.

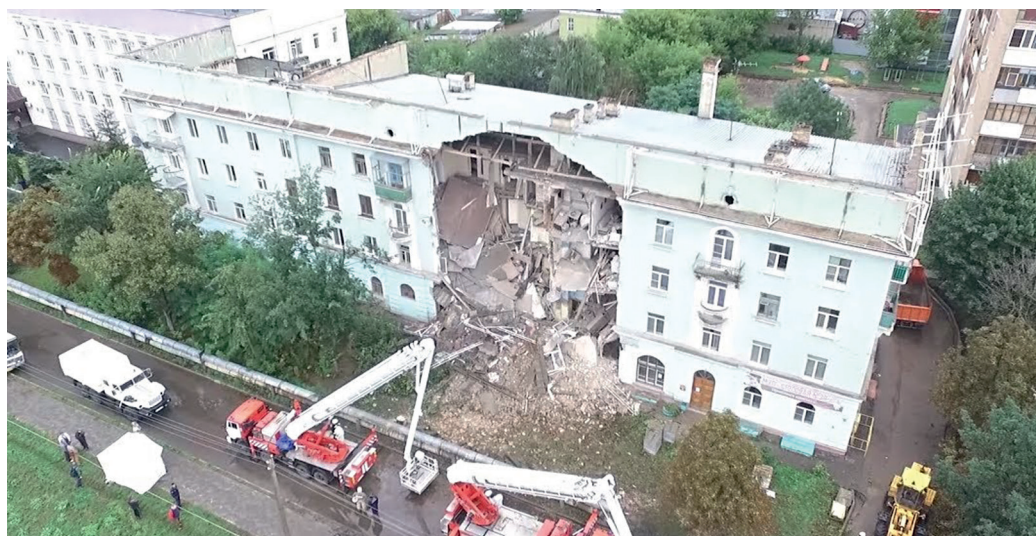
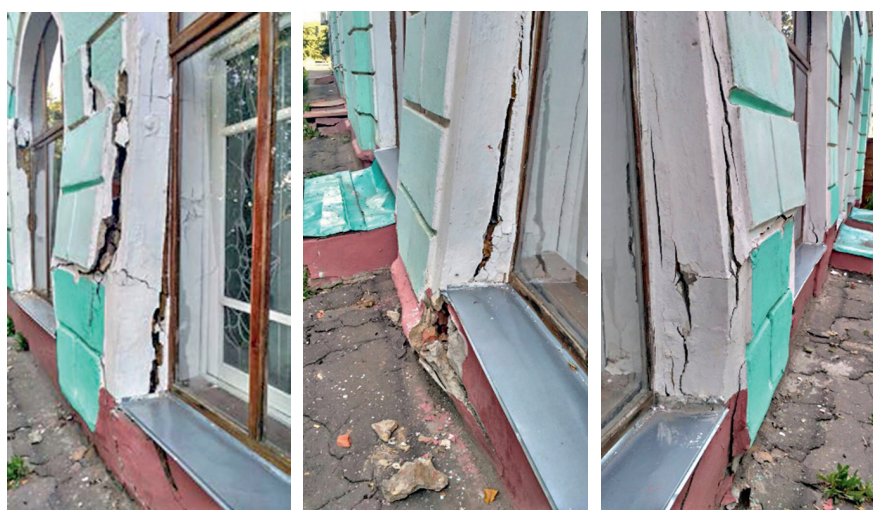
Fig. 3. General view of an apartment building along the Dubrovinsky Embankment in the city of Orel after the collapse: a — emergency condition of the first-floor walls; b — recorded before the collapse

On 29.08.2017, the middle section collapsed within one span of a 4-storey residential building in the city of Orel along the Dubrovinsky Embankment (Fig. 3, a). The house was built in 1955 with brick walls and wooden floors, located in close proximity to the Oka River.

Shortly before the collapse, damage was recorded in the piers of the first floor: vertical cracks along the entire height of the piers with an opening width of more than 1 cm, layering of the masonry into thin flexible columns and bulging of the outer wythe (Fig. 3, b). This state of brickwork corresponds to the 3–4 stage of destruction, which is the final stage of masonry destruction, when through cracks do not stabilize, but continue to develop and increase without increasing the load [14].

The reasons for this weakening of the masonry were the regular soaking of the structures of foundations, walls and pillars by groundwater and floodwaters, leaks from engineering communications, inadequate horizontal waterproofing of walls, uneven degradation of the strength and deformation properties of the masonry solution within the seam. Concomitant unfavorable factors, due to which additional uneven deformations appeared — precipitation of foundations, were the construction work during the construction of the Oka River embankment in 2015 using heavy machinery, and possible vibrational decompression of the foundation soils.

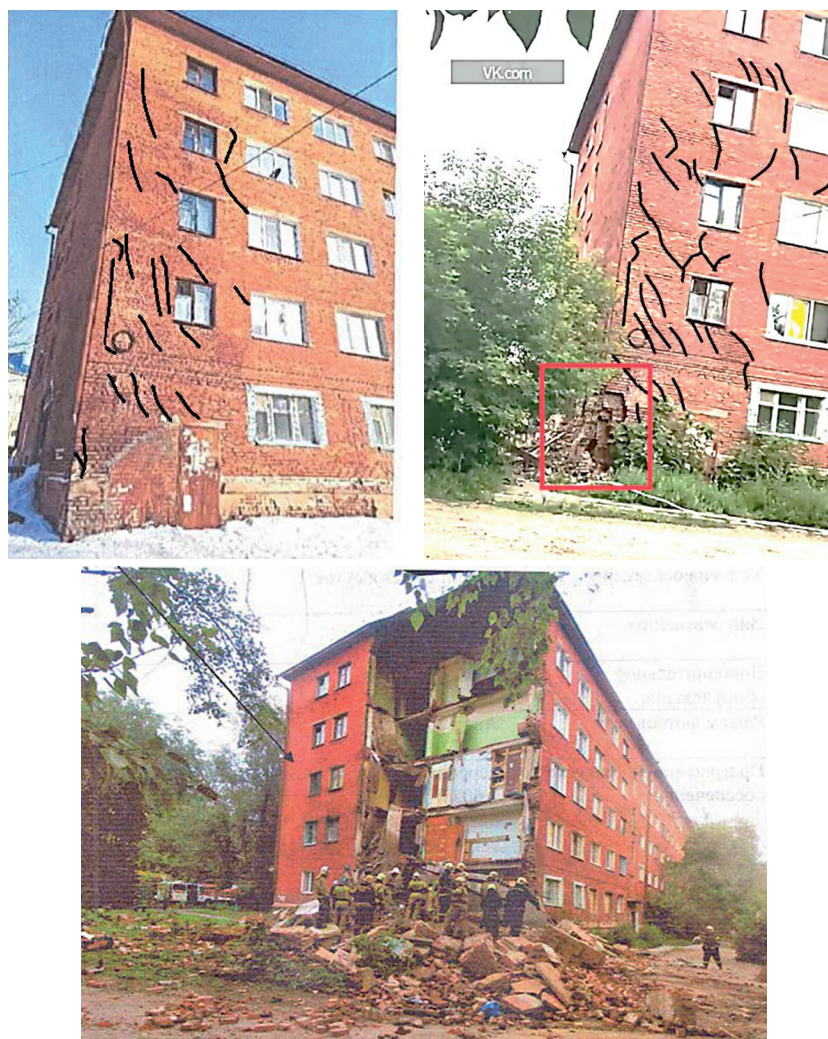
Fig. 4. General view of an apartment building in XX Partsezda St. in Omsk before and after the collapse (the arrow shows the progressive destruction of the corner section of the outer wall a few seconds before the collapse of the end part of the building)

On 12.08.2022, the end part of a 5-storey building in XX Partysyezda Street in Omsk collapsed (Fig. 4). In 2024, a secondary collapse occurred in a resettled but not demolished building, as a result of which the floors from 1st to 5th collapsed adjacent to the previously destroyed site. 1st floor and a full-height longitudinal exterior wall.

The house was built in 1966 with brick walls and prefabricated reinforced concrete floors. The cause of the collapse was the loss of the bearing capacity of the brickwork (made of clay bricks) of the basement of the building at the intersection of the end and longitudinal exterior walls. The collapse was preceded by systematic

leaks from engineering communications in the basement. The brickwork at the basement and ground floor levels, where the wet rooms are located, was systematically saturated with capillary moisture, and on the street side it was subjected to repeated freezing/thawing. Subsequently, this caused a significant decrease in the bearing capacity of the masonry — buckling deformations of the outer wythe appeared according to the 3–4 stage of destruction scheme [14] and further avalanche progression of damage deep into the section under load.

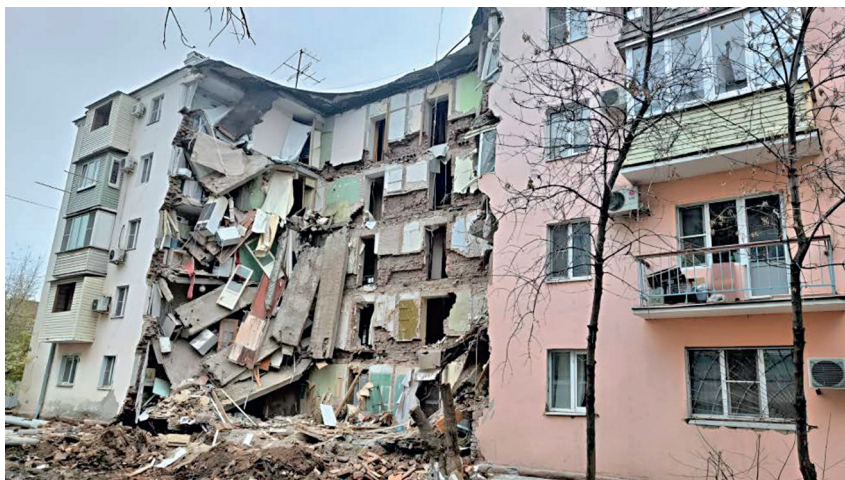
Fig. 5. General view of a destroyed apartment building in the Leninsky district 1a Vokzalnaya Square in the city of Astrakhan

On 16.11.2023, the third and fourth entrances of a five-story apartment building in the Leninsky district at 1a Vokzalnaya Square in Astrakhan collapsed (Fig. 5). The house was built in 1962 with brick walls and prefabricated reinforced concrete floors (3 walls). The foundation is ribbon; the building is basement-free. The supporting structure of the ceiling was wooden, with beams supported on brick pillars on the ground. Partially, the floors at the indicated mark were made of concrete on the ground (under the bathrooms). To maintain communications and maintain them in proper condition in such a building, it was necessary to open the floors and ceiling structures in the apartments on the first floor. The actual

implementation of horizontal waterproofing and its current condition did not allow for the capillary suction of moisture into the outer wall structure from the saturated soil in contact with the wall and led to weathering of the masonry (degradation of strength and deformation characteristics).

Immediately before the collapse, on the section of the outer wall that subsequently collapsed, the presence of oblique cracks crossing the sections of brickwork under the window openings from the first to the fifth floor was recorded in the level of residential floors. The deformations of the brickwork, uneven in length, which were accompanied by a skew in the geometry of the window openings, the window cover burst fullness, a characteristic crack was heard. As a result, the cause of the collapse, as well as in the previous case, was the weakening of the strength and deformation characteristics of the masonry at the basement and ground floor levels due to environmental influences as a result of systematic leaks from engineering communications. Moreover, the physical wear calculated according to the method [3] on the date preceding the collapse was 51 %.
